Comments on Draft report on Hoosier Energy- Frank E. Ratts Generating Station

Re: AMEC Earth & Environment, Inc., *Draft Report of Dam Safety Assessment of Coal Combustion Surface Impoundments, Hoosier Energy, Frank E. Ratts Generating Station, Petersburg, Indiana, September 2010.*

**SUBJECT:** Review Comments on Draft AMEC Dam Safety Report  
Ratts Generating Station, Petersburg, IN

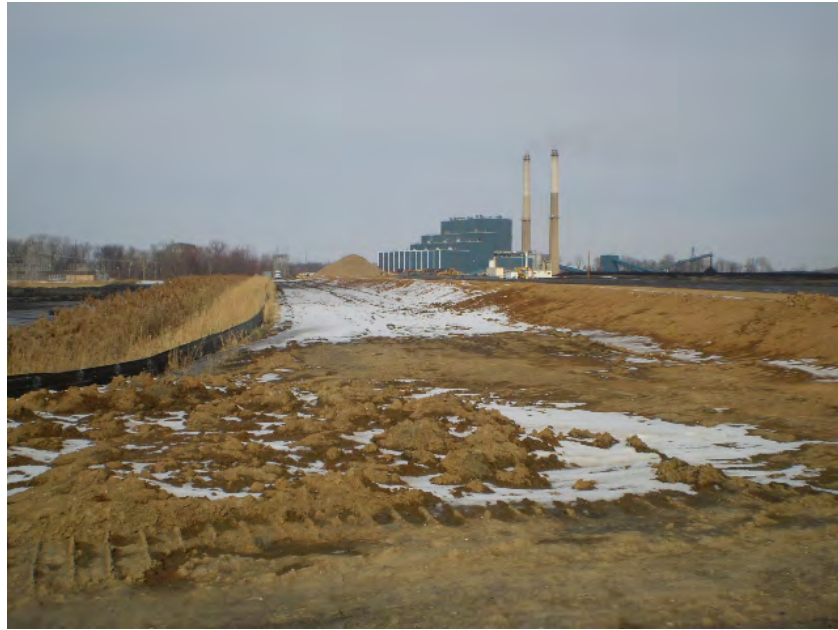
Photo 1: Pond 4 (Fly Ash Pond) Looking North from SE

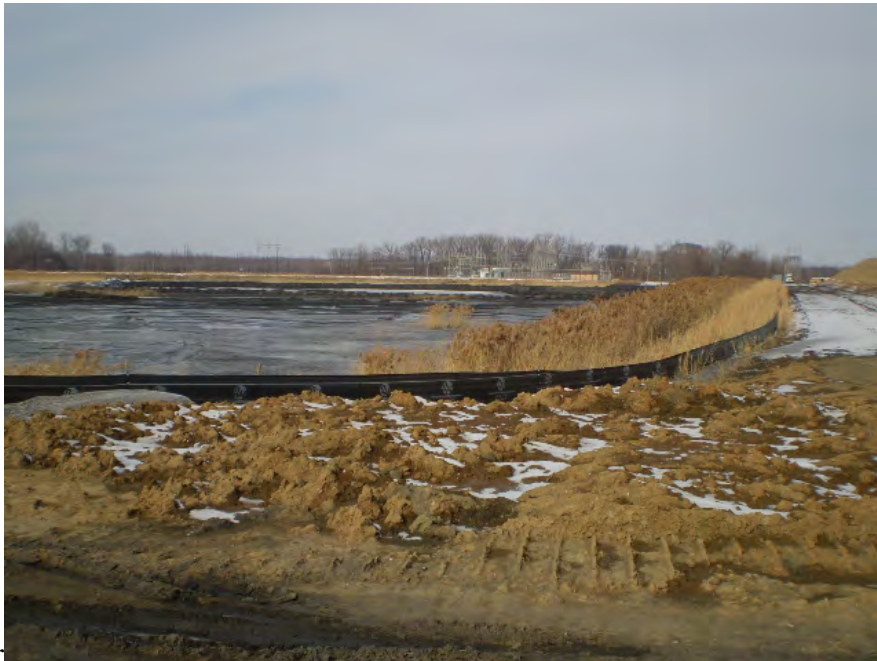
Photo 2: Pond 4 (Fly Ash Pond) Looking Northwest from SE Corner

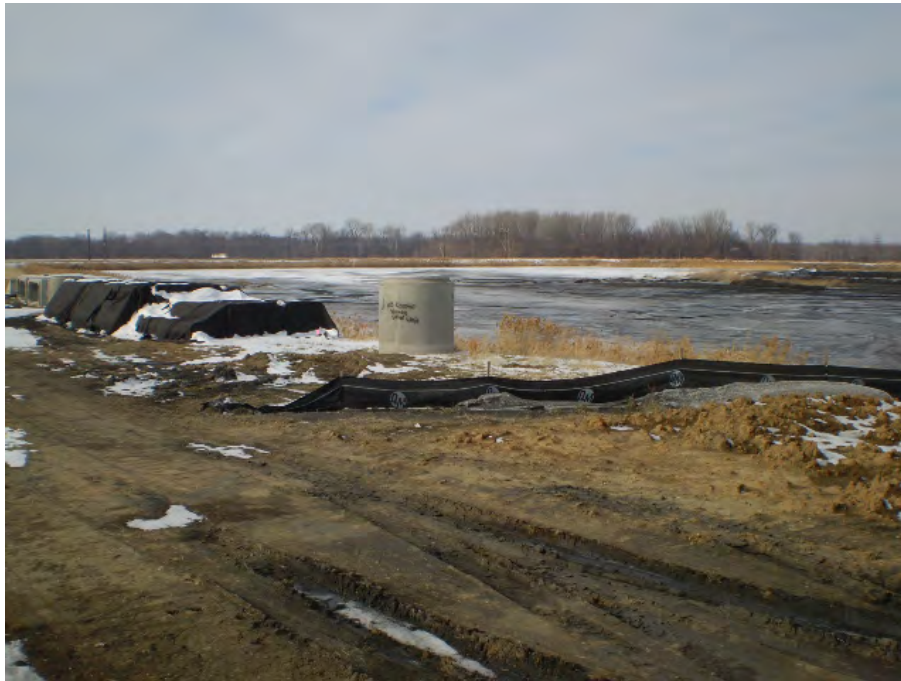
Photo 3: Pond 4 (Fly Ash Pond) Looking Northwest from SE Corner

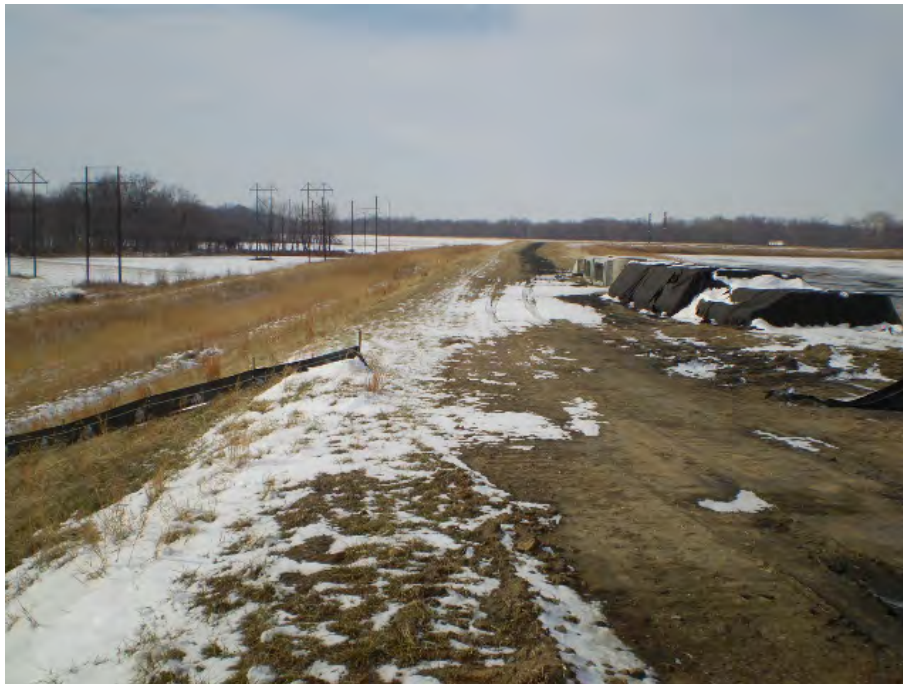
Photo 4: Pond 4 (Fly Ash Pond) Looking West from SE Corner

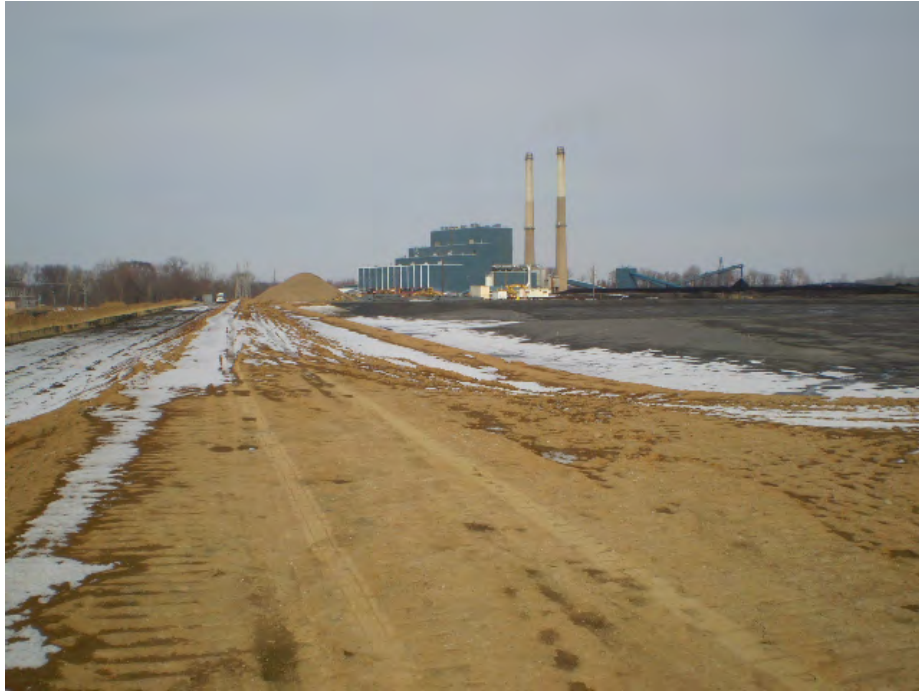
Photo 5: Ponds 2 and 3 Looking North from SE Corner of Pond 4

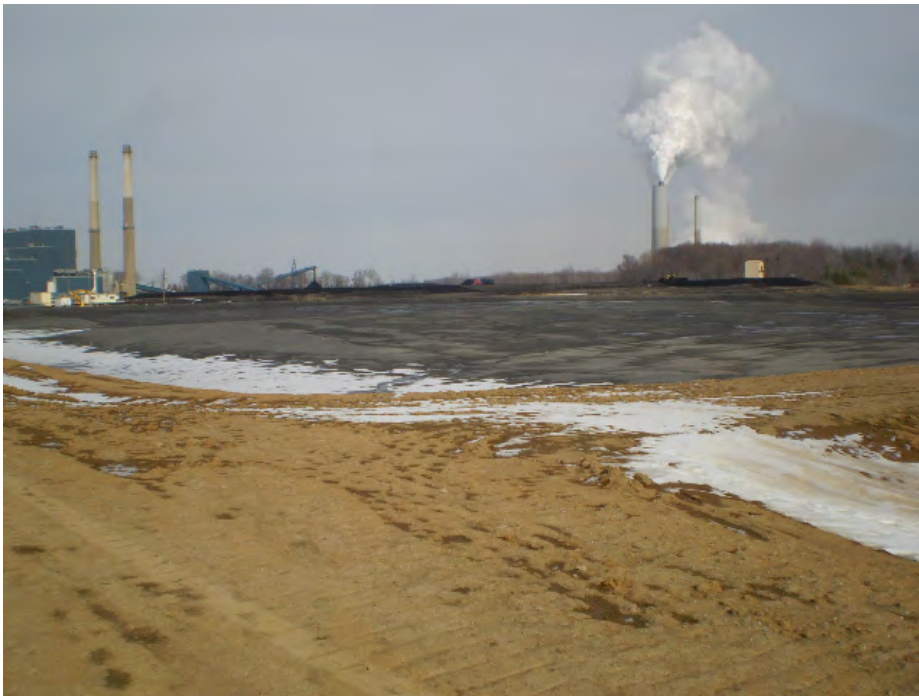
Photo 6: Ponds 2 and 3 Looking Northeast from SE Corner of Pond 4

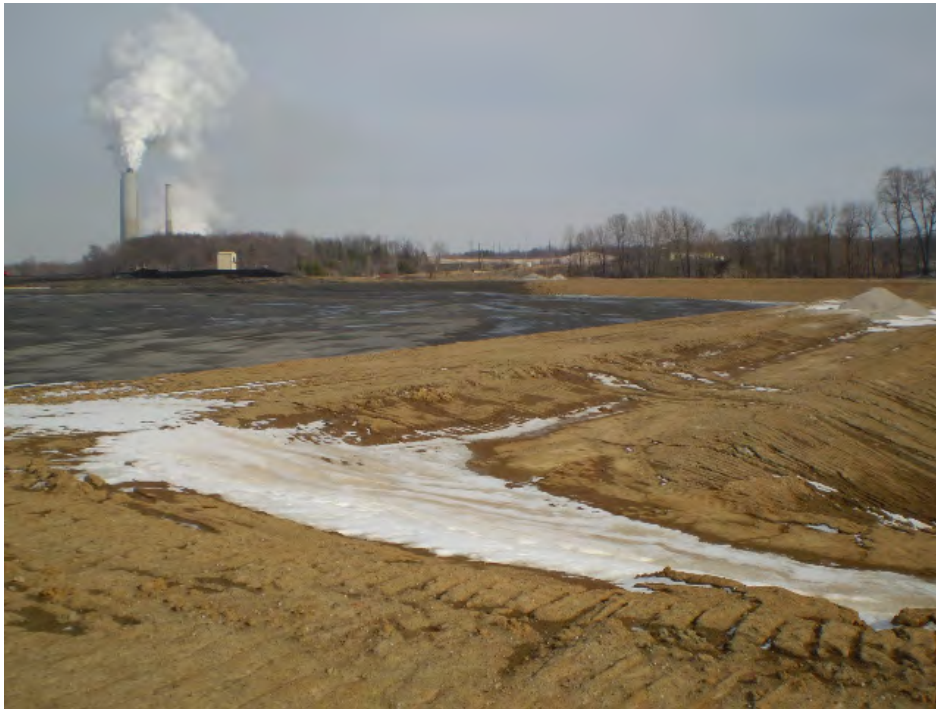
Photo 7: Ponds 2 and 3 Looking Northeast from SE Corner of Pond 4

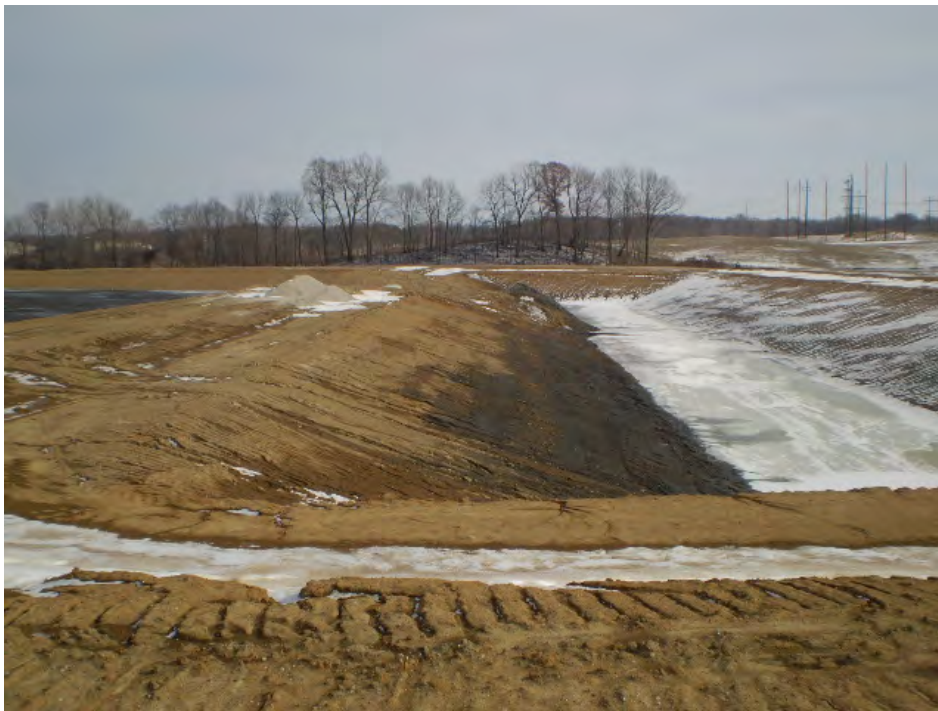
Photo 8: Ponds 2 and 3 Looking East from SE Corner of Pond 4

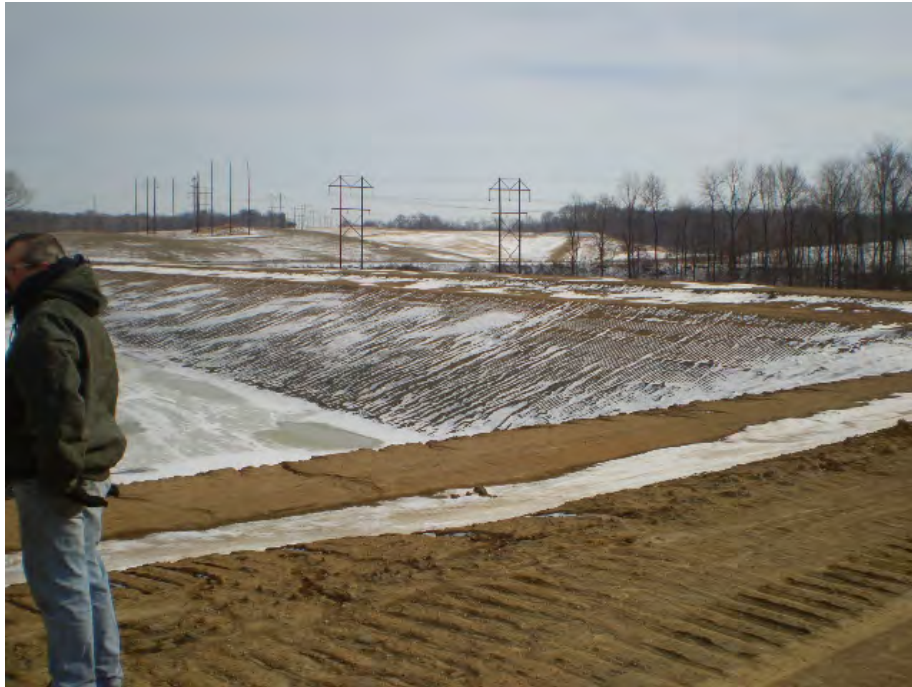
Photo 9: Ponds 2 and 3 Looking Southeast from SE Corner of Pond 4

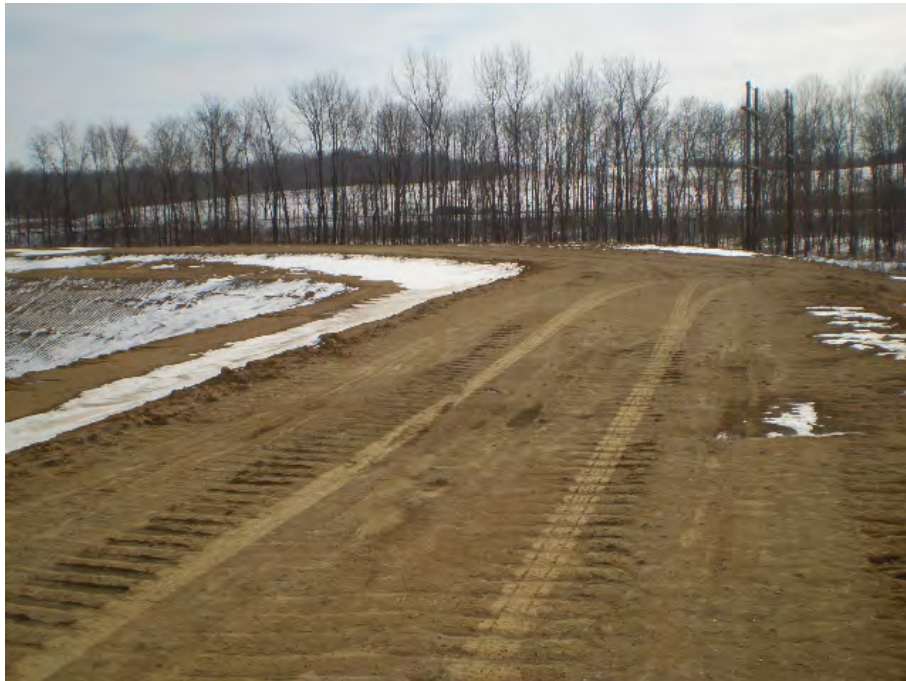
Photo 10: Ponds 2 and 3 Looking East from SE Corner of Pond 4

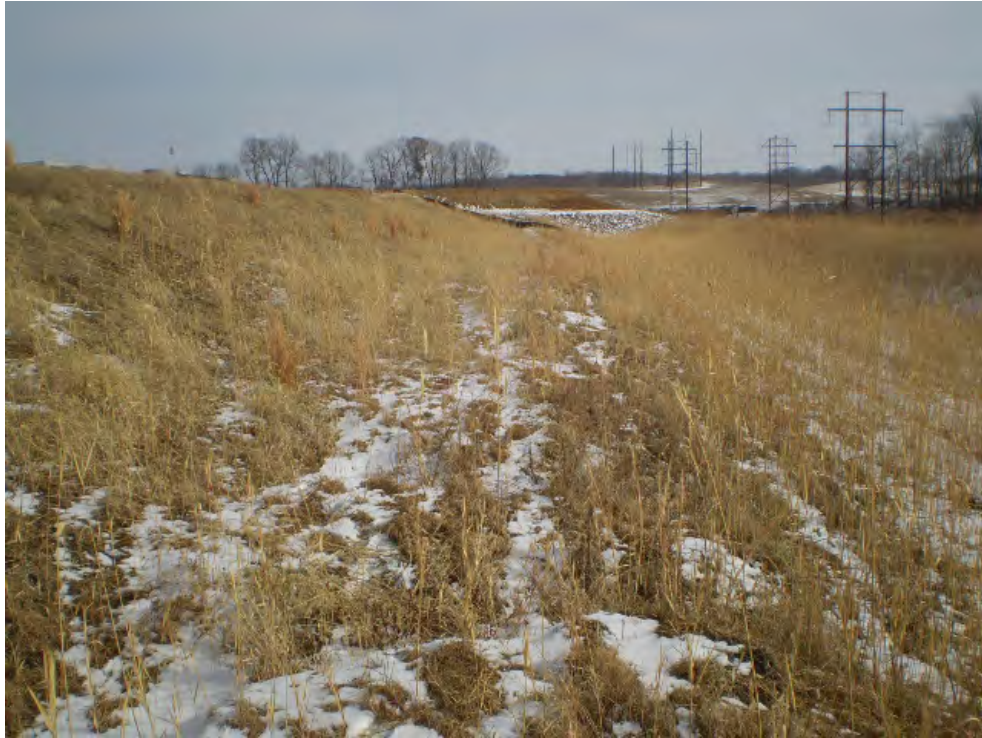
Photo 11: Area Between Inner and Outer Berm Along Southern End of Pond 4 (Looking East)

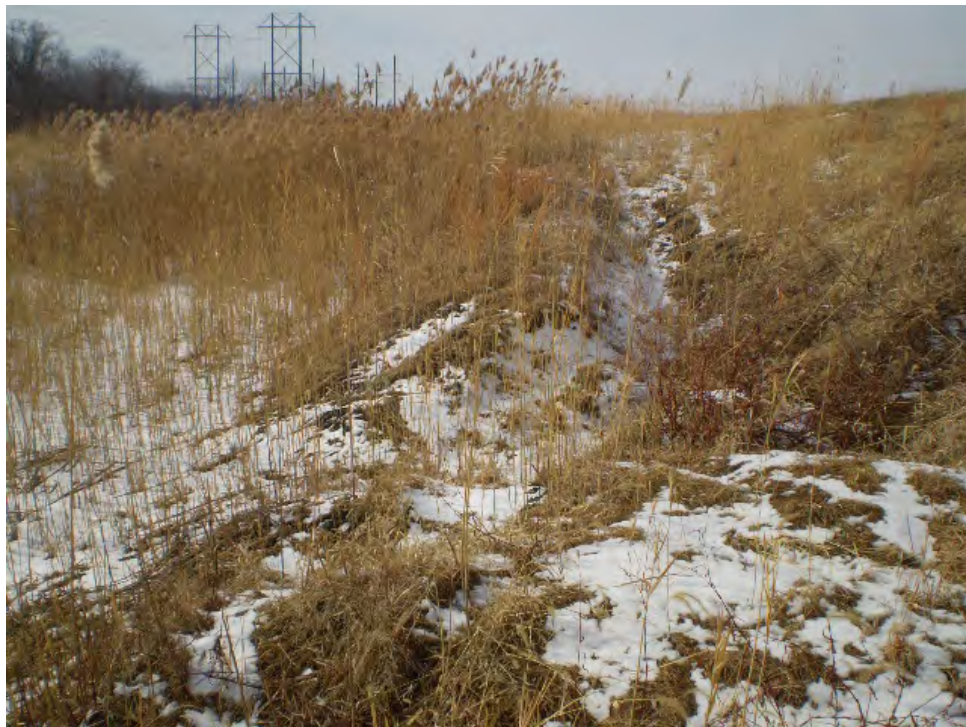
Photo 12: Area Between Inner and Outer Berm Along Southern End of Pond 4 (Looking West)

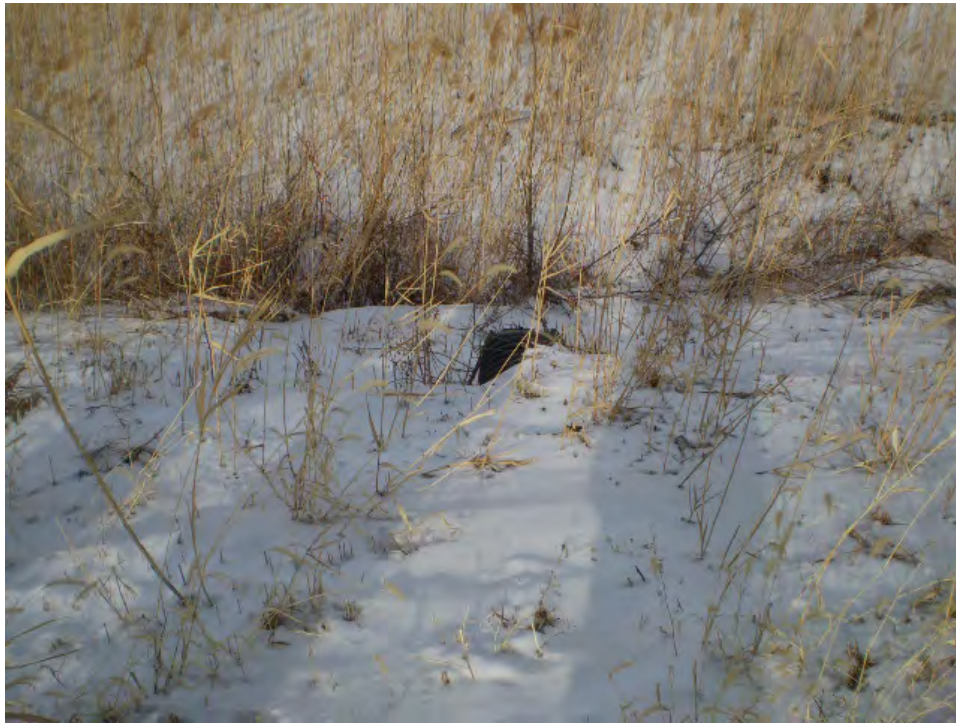
Photo 13: High Discharge Point from Pond 4- Not in Use (Lower Discharge Point in Use)

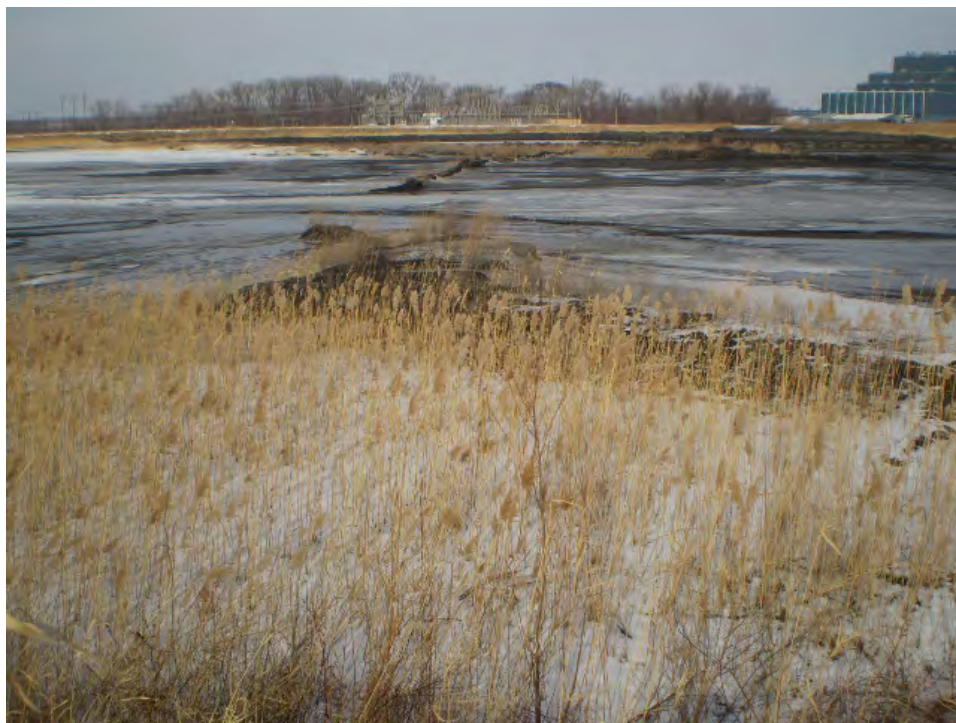
Photo 14: Pond 4 Looking from SE Corner Toward NE Corner

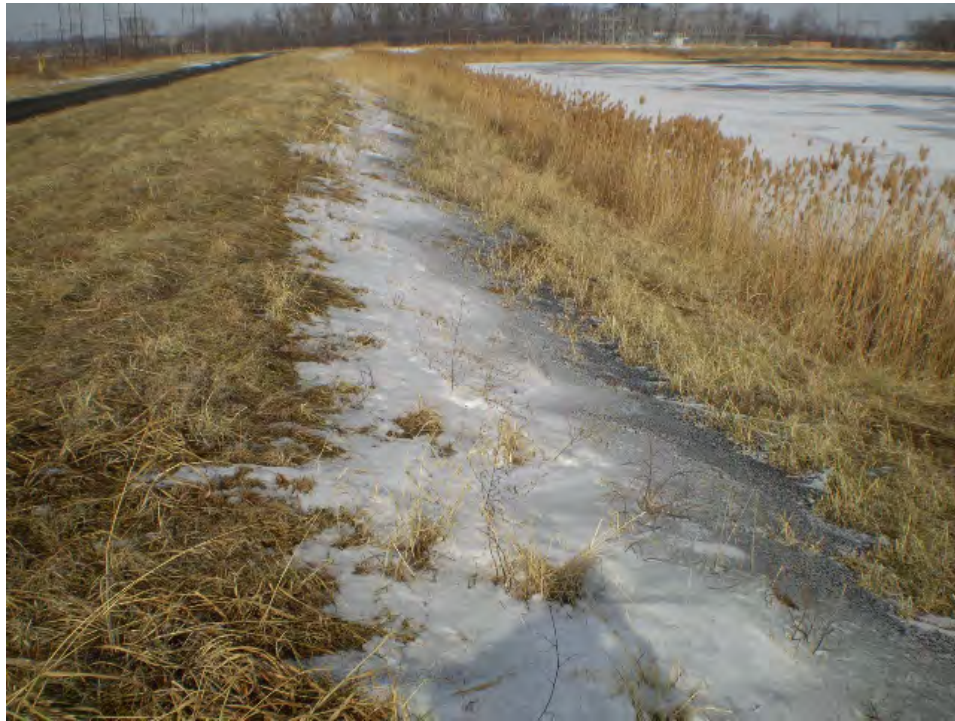
Photo 15: Inner Side of Pond 4 West Inner Berm

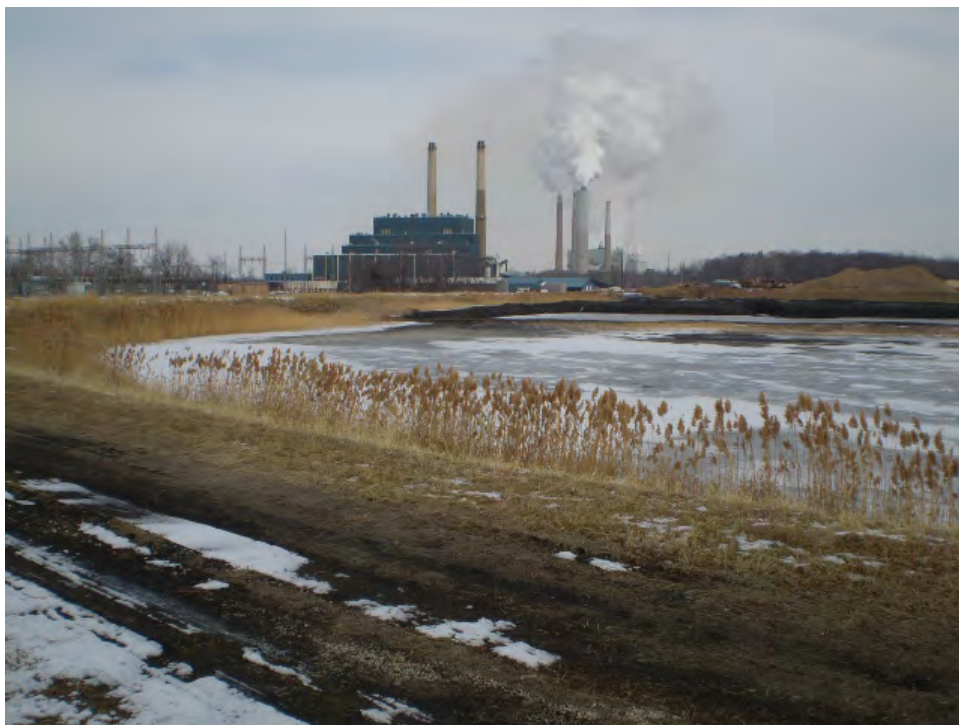
Photo 16: Northeast Corner of Pond 4

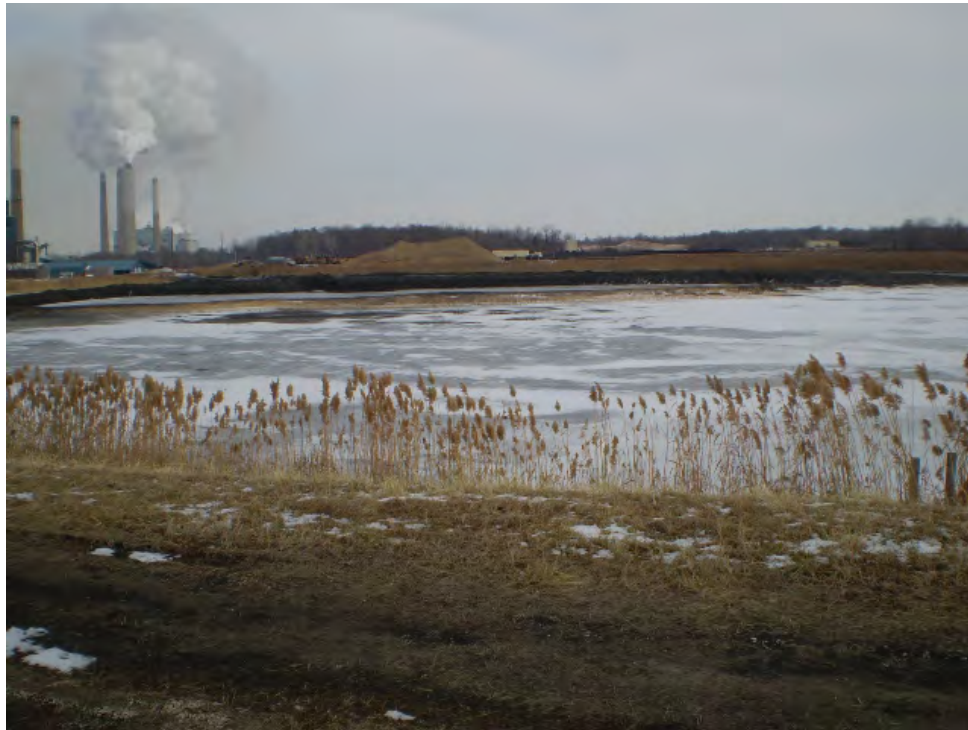
Photo 17: Northeast Corner of Pond 4

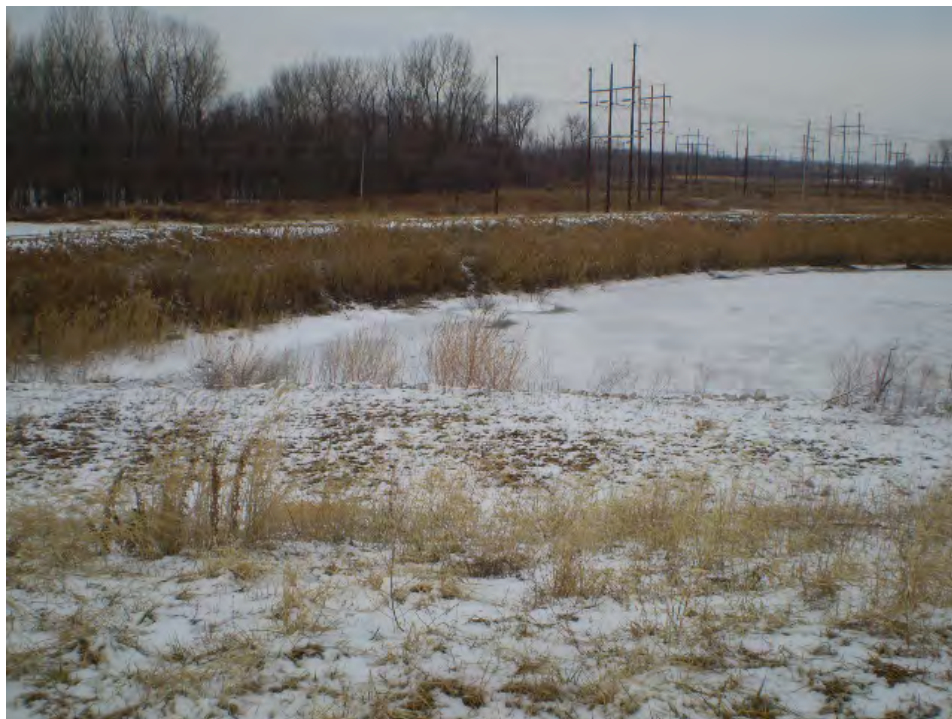
Photo 18: Settling Basin at North End of Pond 4

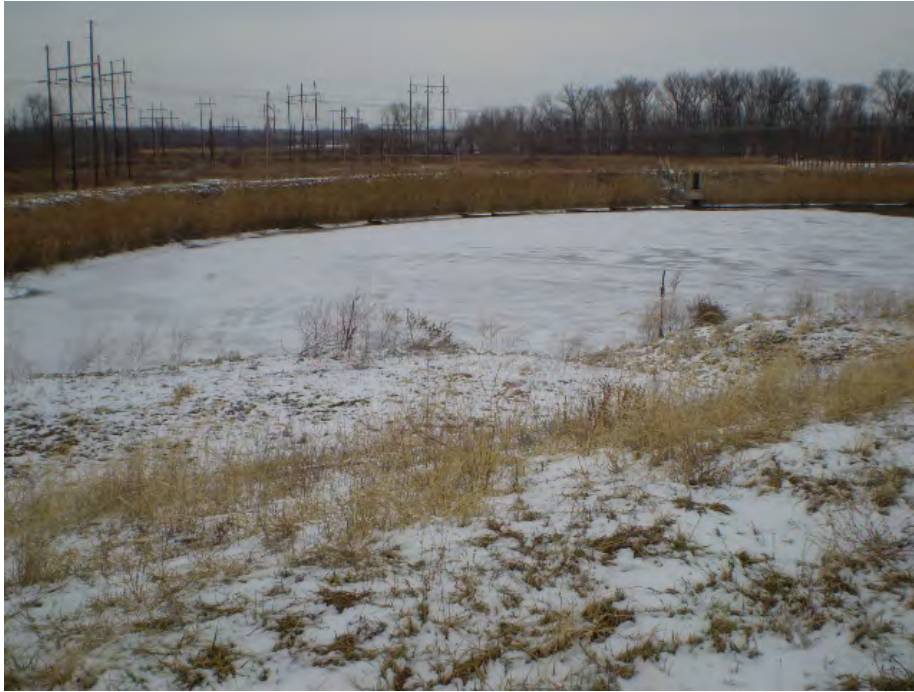
Photo 19: Settling Basin at North End of Pond 4

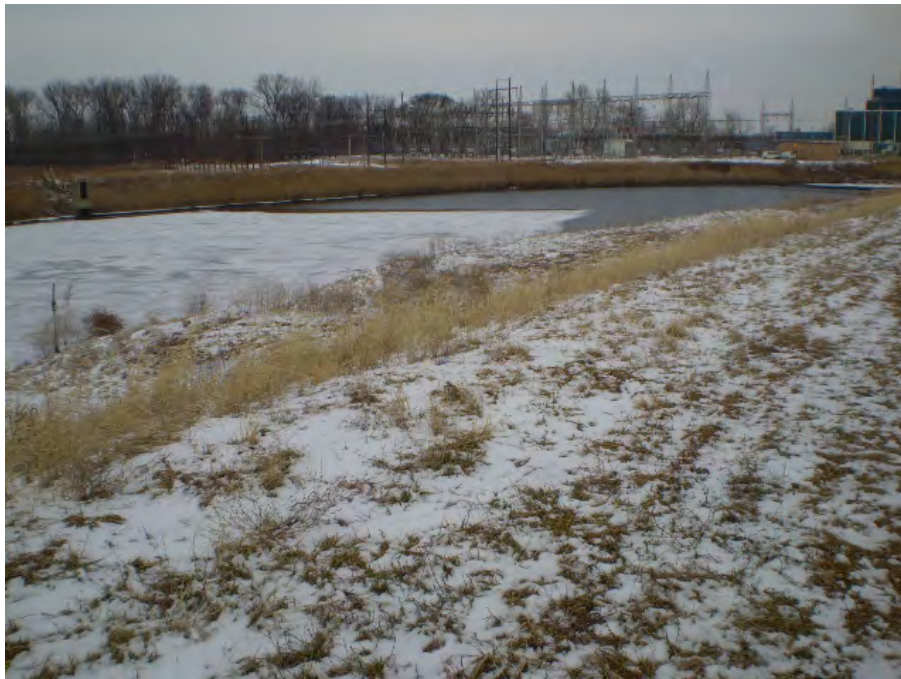
Photo 20: Settling Basin at North End of Pond 4
